HIGHLAND LAKE DAM

NJ00033

PHASE 1 INSPECTION REPORT  
NATIONAL DAM SAFETY PROGRAM

August, 1979

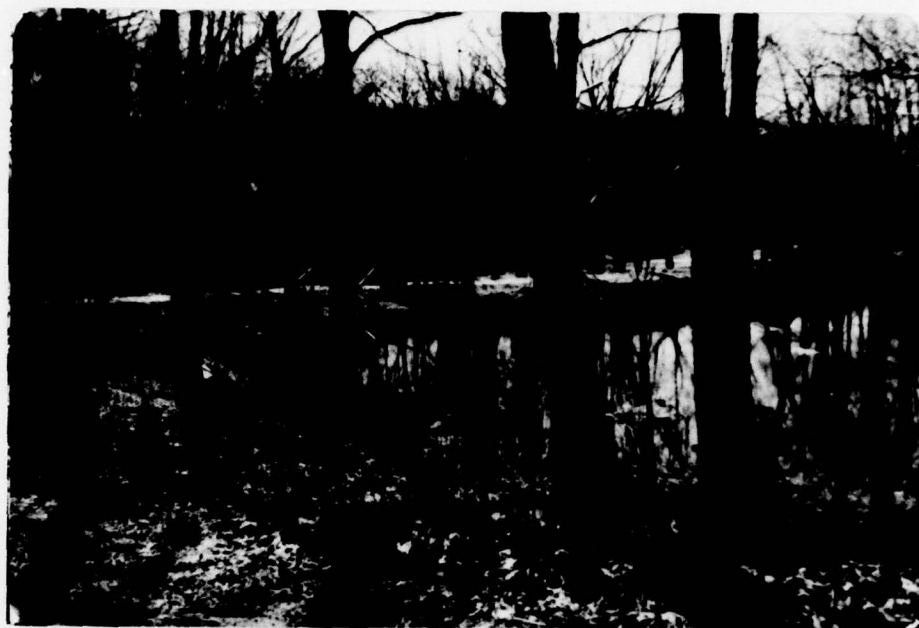
The two ogee crested spillways are in solid but weathered condition but the downstream channel capacity of spillway #1 is somewhat restricted by a stone masonry wall positioned 2 to 3 feet immediately below the crest. The discharge drops into a narrow channel about 4 foot deep where it flows laterally to the right and enters a short section of rectangular concrete channel. Spillway #2 (near the left abutment) is now topped by a timber bridge which provides access to the residence on the peninsula. The hydraulic headroom under the bridge soffit is about 2 feet but the 12 foot weir is positioned sufficiently upstream of the bridge fascia so that it does not restrict the discharge. The discharges from the two spillways merge just south of Lakeside Drive (which crosses the dam) and flow north thru two 48 inch diameter pipes under the road.

View of Primary Spillway

(1) The cracks in the ogee weirs should be filled with epoxy and the expansion joints at the corners of spillway #2 wingwalls recaulked.
